BOMB CRATER REPAIR TECHNIQUES FOR PERMANENT AIRFIELDS

Report I

SERIES I TESTS

David L. Cooksey

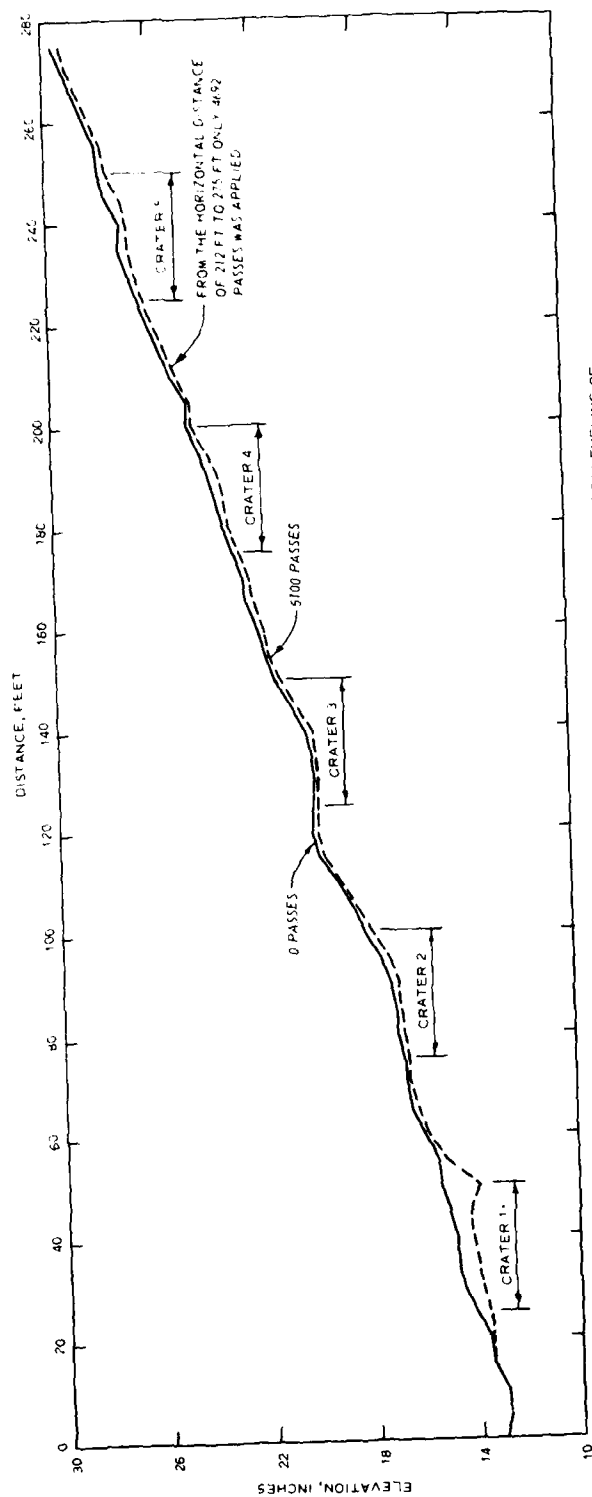
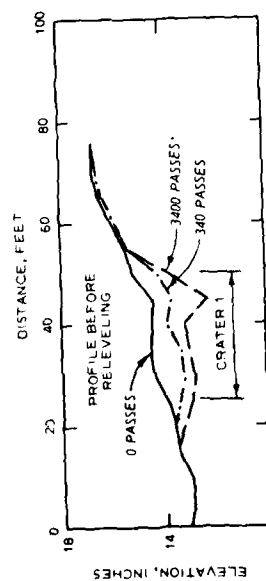
Figure 9. Profile of center of traffic lane 1

*PROFILE AT 5100 PASSES REFLECTS RELEVELING OF SURFACE OF CRATERS. 3400 PASSES AND TRAFFIC CONTINUED TO 5100 PASSES.

consolidation as shown on Figure 11. No abnormal ruts were present at the completion of traffic. This is also evident in the profile of lane 1 (Figure 9).

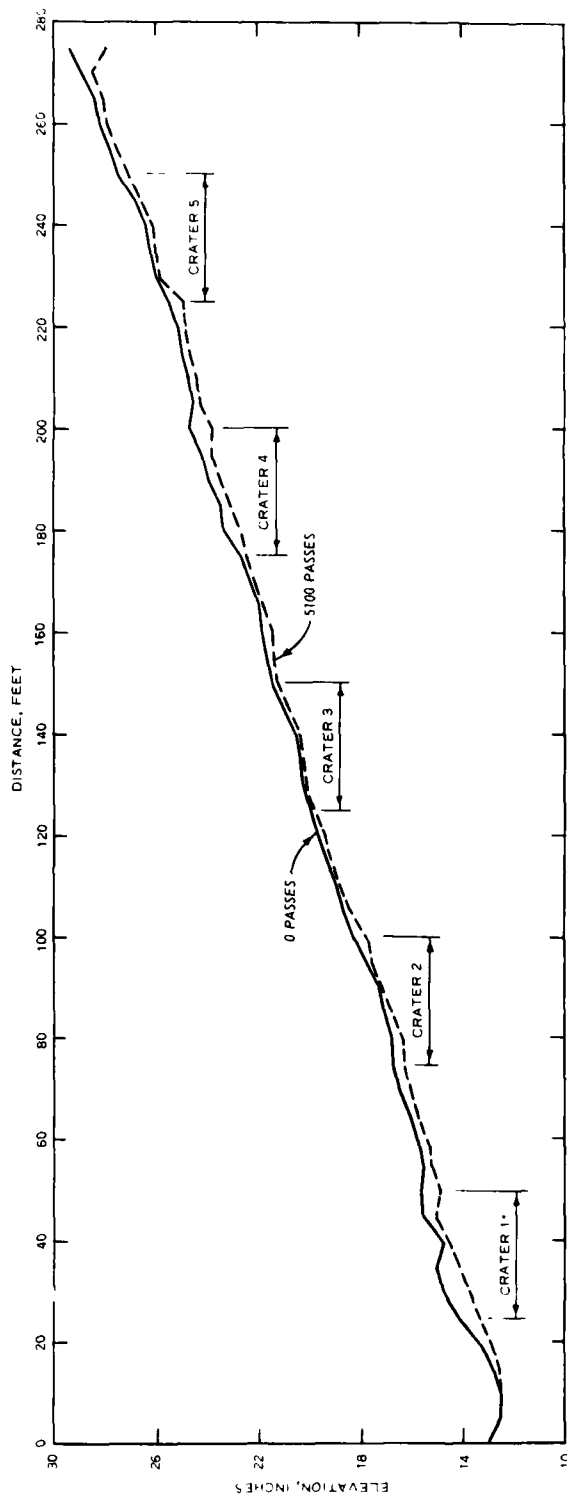
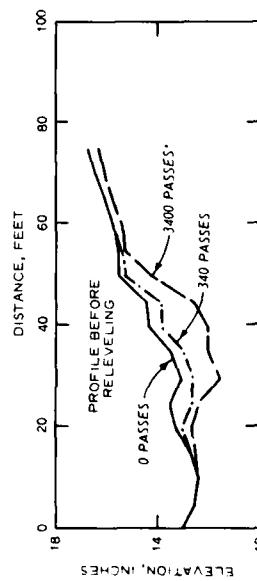
Figure 10. Profile of center of traffic lane 2

*PROFILE AT 5100 PASSES REFLECTS RELEVELING OF SURFACE OF CRATERS AT 3400 PASSES AND TRAFFIC CONTINUED TO 5100 PASSES.

and it was exposed to the cold and wet climate for 4 months before traffic was resumed. During the initial 10 passes of traffic, the drive wheels of the load cart caused the bond between the fabric and limestone surfaces to fail and wrinkles developed in the fabric (Photo 82). The individual pieces of limestone began to penetrate the film in several places (Photo 83). Moisture was found to be present beneath the fabric and there was little bond to keep the fabric in place. Therefore, the fabric was removed at the completion of 10 passes of traffic. As traffic continued to 5100 total passes with the C-141 load cart, some limestone was displaced due to traffic operations and due to rainfall. The average rut depth had increased to 0.5 in. at the completion of traffic (Photo 84). Figure 11 shows cross sections indicating some densification in the repaired crater. This is also evident in the profile of lane 2 (Figure 10).

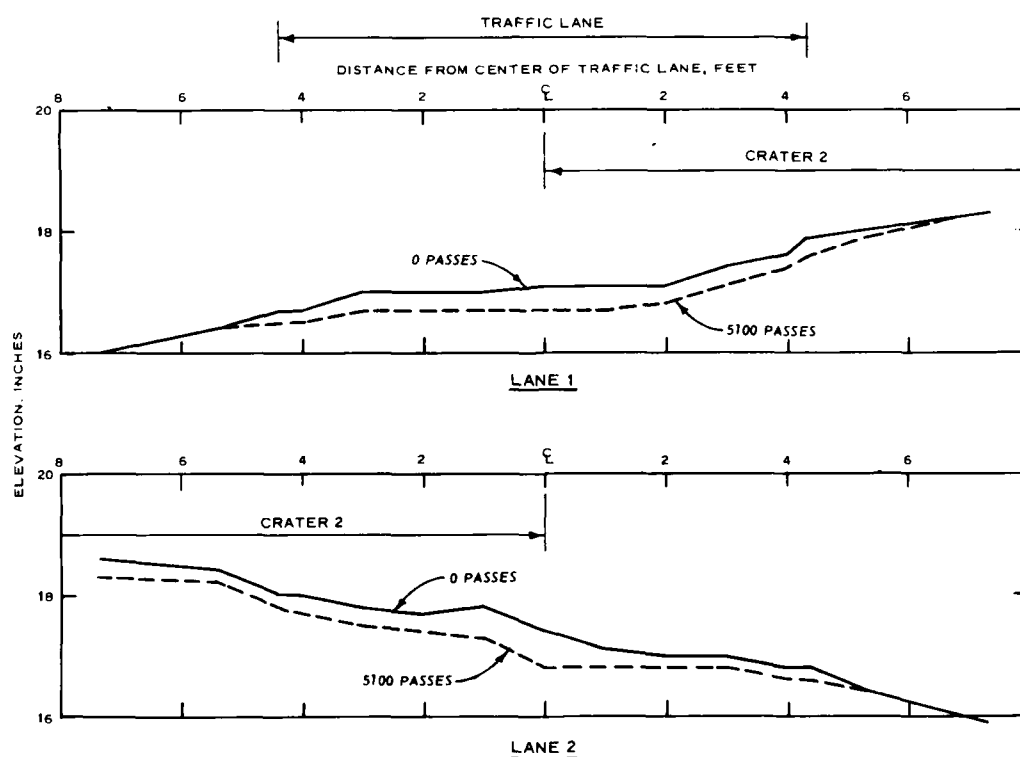
Figure 12. Cross section of crater 2 repair

cracks, but there was visible spalling over the moment transfer devices (Photo 88). There was some progression of existing corner breaks and spalling in these areas and along the crater joints after 3400 passes of the C-141 load cart (Photo 89). Spalling was the most visible indication of the effect of the prolonged traffic after 4692 passes of C-141 traffic (in addition to 760 passes of the F-4C load cart). A view of the portion of crater 2 located in lane 1 is shown in Photo 90. No structural damage to the repair that would have any effect on traffic was observed at this time. After the 4-month delay, traffic was resumed and an additional 408 passes of C-141 traffic was applied, resulting in a total of 5100 passes of the C-141 load cart. The additional traffic caused no new corner breaks and only a small amount of spalling occurred at the crater edges (Photo 91). The repair method was considered satisfactory from a performance viewpoint. Cross sections of crater 2 are shown in Figure 12. A profile of crater 2, lane 1, is presented in Figure 9.

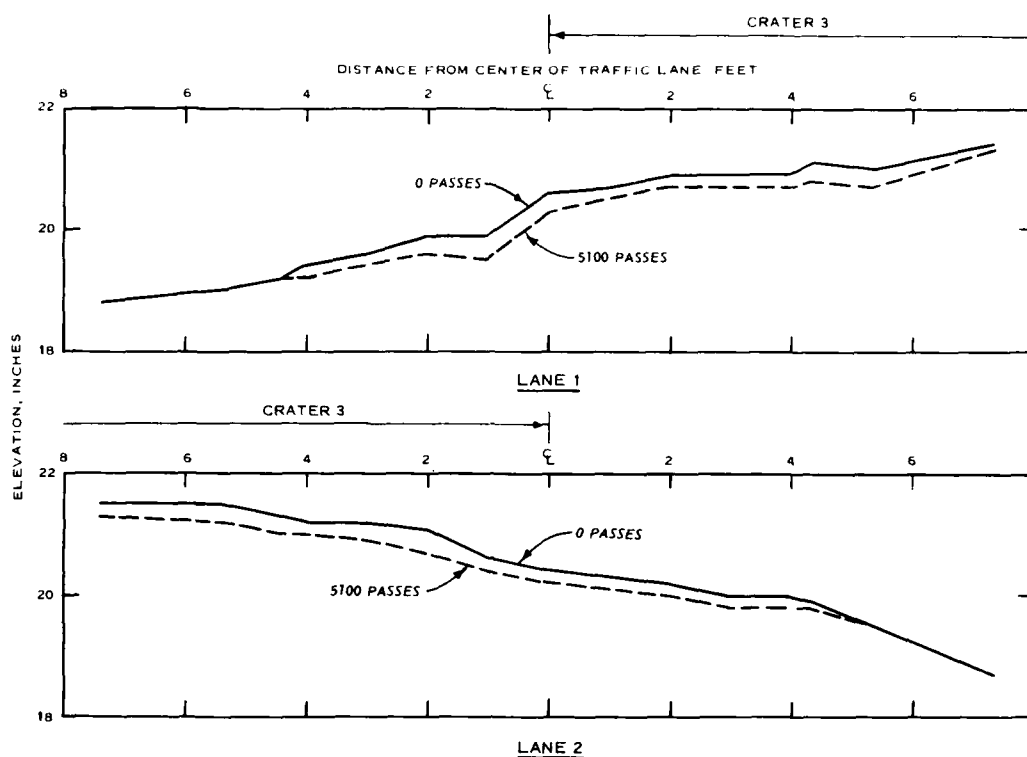
Figure 13. Cross section of crater 3 repair

Within 48 hr after grout placement and after the F-4C traffic, C-141 traffic was begun. Corner breaks in each corner of the crater repair were first noted after 80 passes of the C-141 load cart. After 1020 passes of traffic, the southwest corner still had one corner break and the southeast corner contained two. As traffic increased to 1700 passes, spalling began to develop and the corner breaks were still quite evident. The main corner breaks were painted for identification (Photo 99). After 3400 passes of traffic, two additional corner breaks were evident and spalling was increased along the crater joints and over the moment transfer devices (Photo 100). Spalling was greatly increased after 4692 passes of C-141 traffic (plus the initial 760 passes of F-4C traffic), but there was no increase in the number or size of the corner breaks (Photo 101). From 4692 passes to 5100 passes only a slight amount of spalling took place, and no new breaks occurred in the crater surface. An overall view of the crater at the completion of traffic showing the repaired test pit is shown in Photo 102. Profiles and cross sections of the portion of crater 3 in lane 1 showed no major changes in the repair other than minor densification of the overall repair (Figures 9 and 13).

Profiles and cross sections showed only densifications occurring in the crater repairs (Figures 10 and 13).

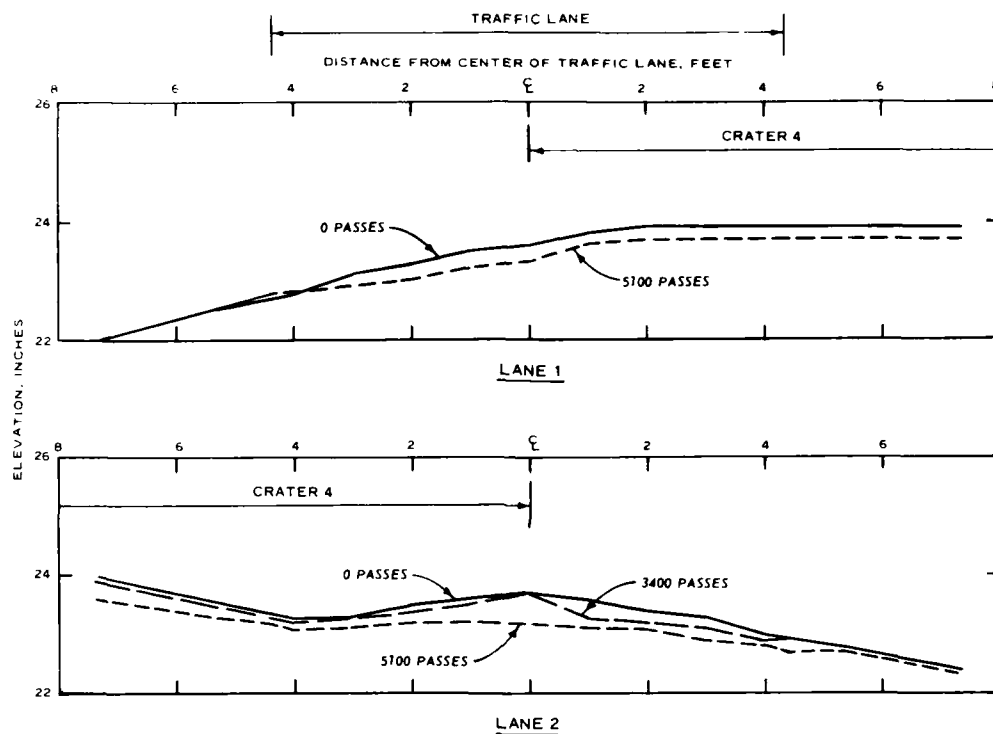
Figure 14. Cross section of crater 4 repair

began to develop along the edges of the crater and in one of the cracks. An overall view of this condition is shown after 4692 passes (Photo 111). Traffic was continued up to 5100 passes and no additional damage was observed in the crater surface. The surface was relatively smooth and free from any major spalling (Photo 112). Both the profile and cross-section measurements showed only minor consolidation after traffic (Figures 9 and 14).

corner breaks in the repair and spalling at the crater edges was considered minimal (Photo 115). Traffic was continued with the C-141 load cart to 5100 total passes. At 3842 passes, a transverse crack developed in the concrete surface but caused no problem. A view of the crater at the completion of traffic is shown in Photo 116. Only a small amount of spalling occurred in the crater. Thus, this type repair and the moment transfer device used were considered to be quite successful. The profile and cross-section measurements showed no major changes after 5100 passes of the C-141 load cart (Figures 10 and 14).

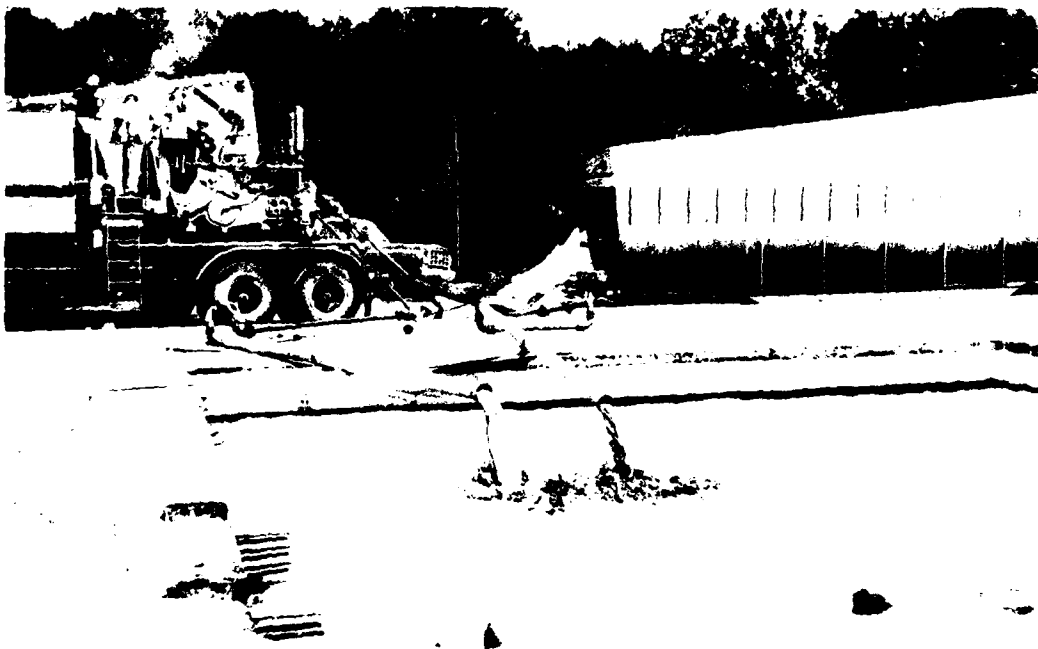
Photo 43. Crater 3 with polyethylene film placed over limestone just prior to grouting. Both the undercut and fabricated moment transfer devices can be observed along the perimeter of the crater

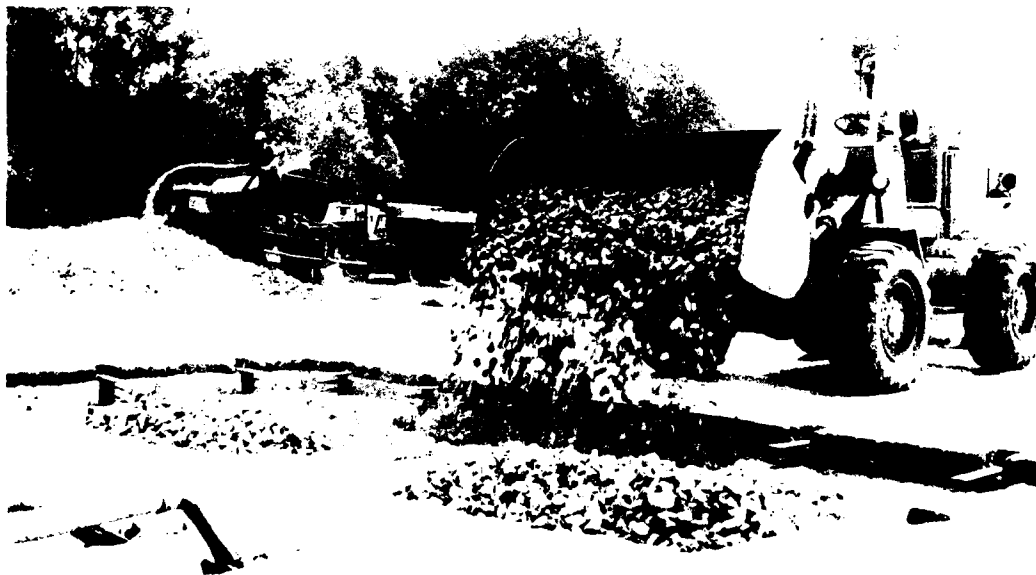
Photo 45. Moment transfer devices located in south half of crater 3 after initial pumping of grout

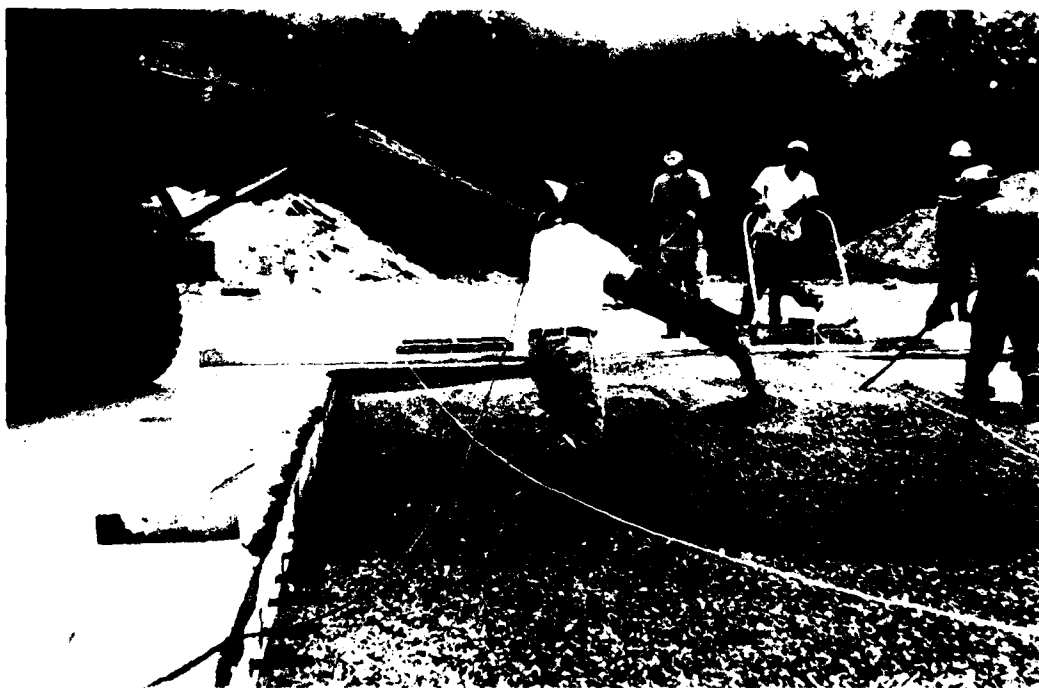
Photo 51. View of crater 4 looking west just prior to concrete placement. The undercut section in the north half of the crater has the steel reinforcement in place and the steel dowels are shown protruding from the slab after being grouted in the drilled holes

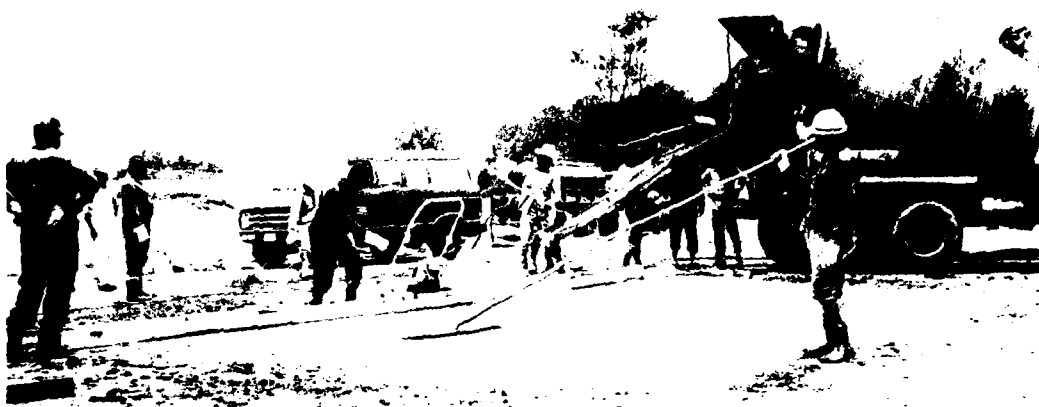
Photo 52. Concrete being placed in crater directly onto washed gravel in crater 4

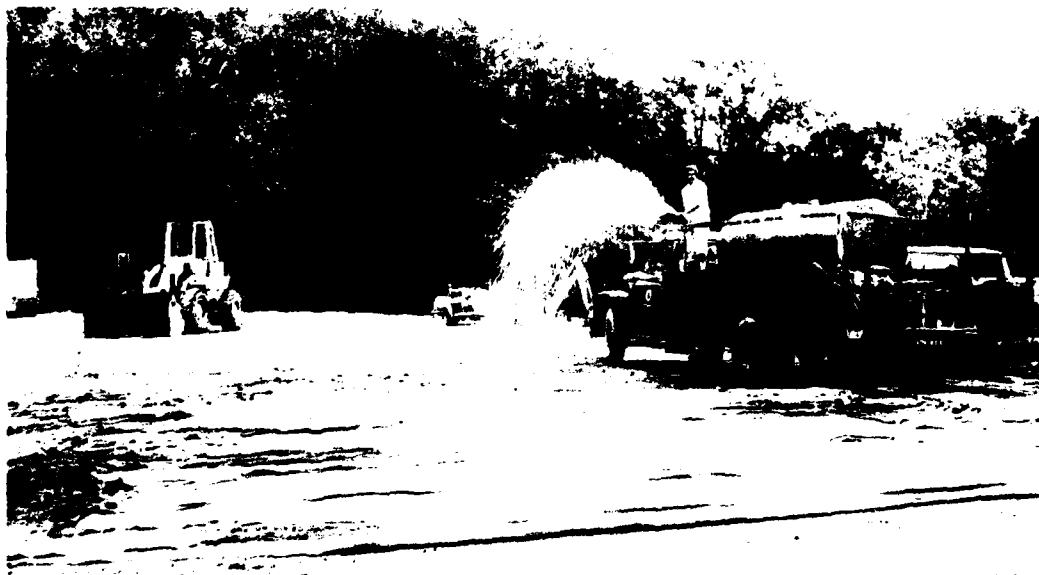
Photo 53. Finishing top surface of crater 4 as concrete placement is being completed

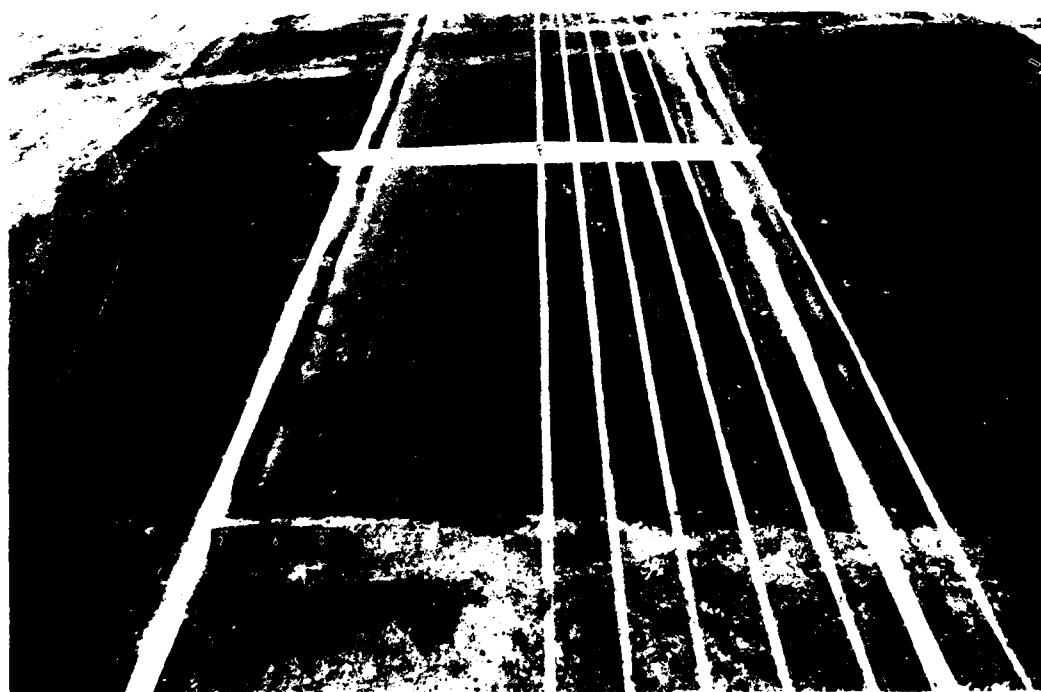
occurred after 5100 passes of traffic and only minor spalling was evident (Photo 125). A test pit in this area revealed a hairline crack in a concrete moment transfer device near the crater face which allowed the pumping of subgrade material. Otherwise, the moment transfer appeared to have no other structural damage. Profile and cross-section data indicated very little change in elevation (Figures 10 and 15).

Photo 125. View of crater 5, lane 2, after completion of trafficking with C-141 load cart
